The hole through Torghatten mountain: nature's own artwork and an object of risk evaluation

Prof. Bjørn Nilsen

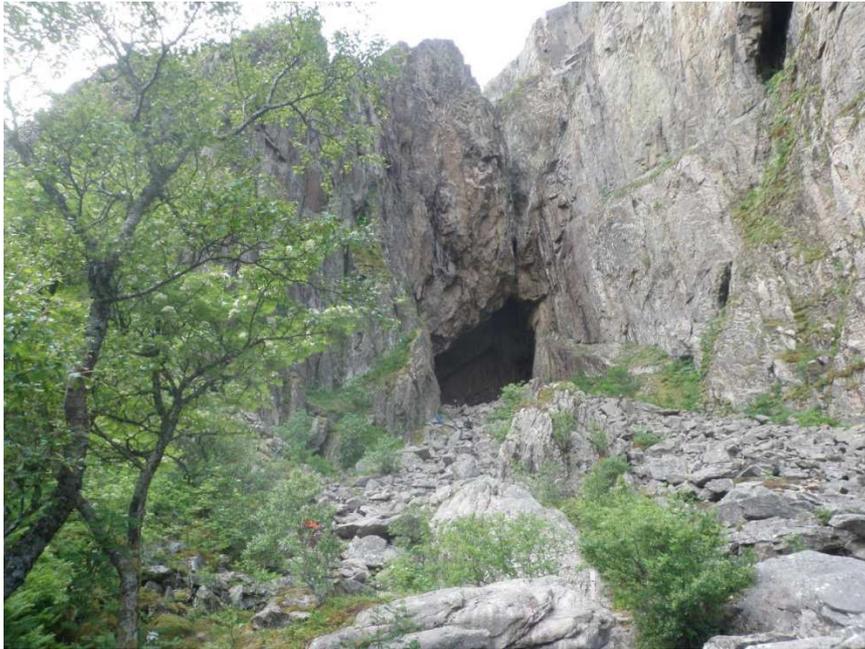
Fig. 2. The entrance to the hole from North. Note persons standing at the entrance to the lower left.

The hole is oriented NE-SW, which coincides with the strike of the foliation and distinct discontinuities in the area. Several of these can be observed in the roof of the cavern, and the two most prominent of the distinct discontinuities form the walls of the hole, see Figs. 2-4. The bedrock in the area consists of Paleozoic granitic gneiss of mainly good quality, but along the hole the rock mass is weaker and more fractured.

The safety for tourists visiting this attraction has been a main concern. Regular inspections for evaluating stability and evaluations of potential measures for reducing risk therefore have been carried out at regular intervals, in most cases by the author as scientific advisor for SINTEF. Most importantly based on these inspections, the trail leading to the hole and through it has been relocated to “safe location” so that the risk of being hit by rock fall has been minimized, and unstable blocks above the entrance to the hole (to the upper right in Fig. 2) have been scaled down.

Any comprehensive rock support such as rock bolting and sprayed concrete are unrealistic for aesthetic reasons. Stability evaluation based on discontinuity mapping has shown that large scale instability is highly unlikely due to the fact that the main structures cause a wedging of the rock mass between, as shown in Figs. 2-3, in such a way that release of large

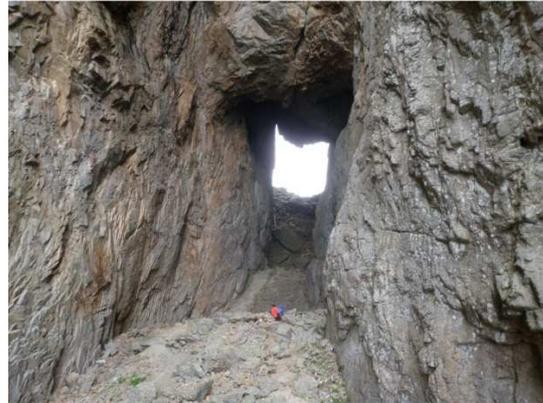
Fig. 4 The southern and central parts of the hole.
